Decontamination Services

Decontamination of Steam Generator Pipe Ends at SONGS U3

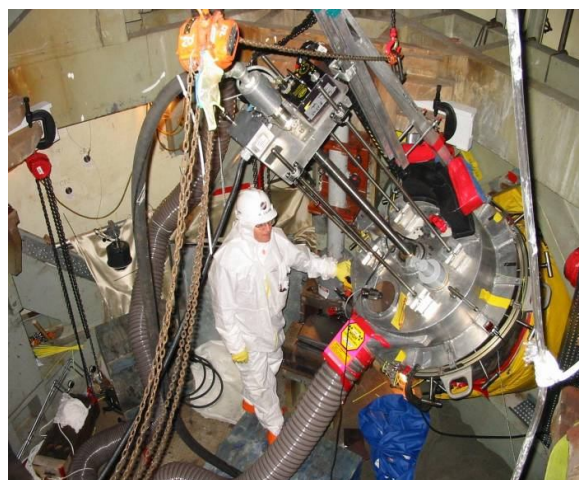
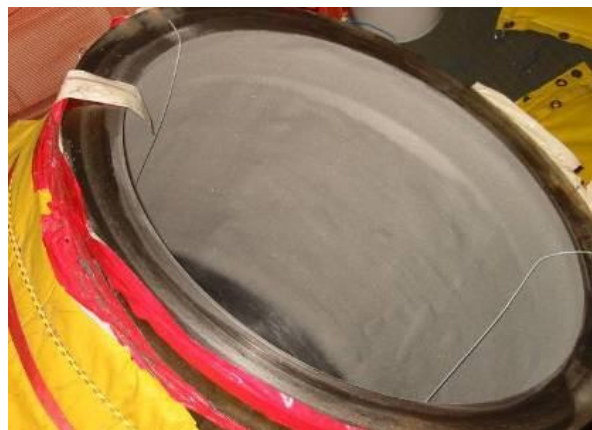
The NuVision sponge abrasive decontamination system operates on a simple, non-recycling process: the sponge media will be blasted into each elbow via a media delivery unit and a blast head. A seal dam is inserted in each elbow to prevent media from entering the Reactor Coolant System (RCS). The media is removed from each elbow after blasting via a portable HEPA vacuum system and is deposited into 55 gallon drums. The blast pressure, media feed rates, and nozzle rotation speed on the blast hopper and blast head are balanced with the vacuum pressure of the HEPA filtration system to maintain a slightly negative pressure within the pipe end /blast housing area. The negative pressure environment assures that our blast process does not create the potential for airborne contamination inside containment when we are performing our decon process. The decon system automatically stops blasting in the event the negative pressure inside the elbow approaches zero.
